Manhole Inspection Summary

Manhole # S47I__004MH

Location Address: **2111 s duncan st**

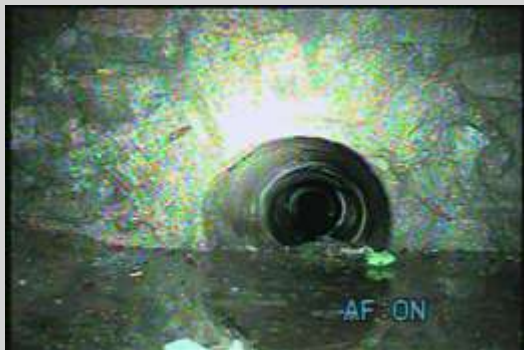
12 O'Clock Outflow

8 in. Circular Gravity Sewer
Pipe Out @ 12 O'Clock

Pipe Material: **Clay** ☐ Pipe Lined

Infiltration: **None**
